# Manhole Inspection Summary

Manhole # S29G\_\_015MH

Insp Date: **4/17/09 1:06 PM**

**Location** Address: **800 S. FREMONT AV**

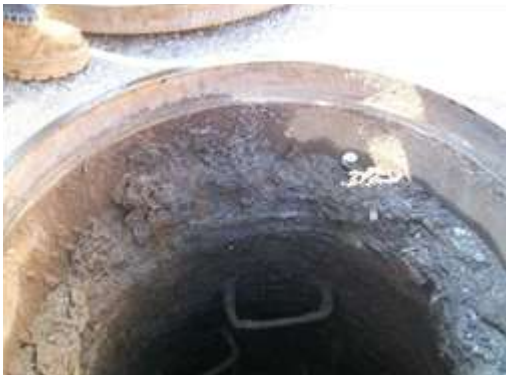
Defect 1

**Frame** Offset: **2.5** (in.) Condition: ☐ Sound ☐ Cracked ☒ **Leaks**

Condition: ☐ Sound ☐ Cracked ☐ Root Intrusion ☐ Loose Brick ☒ **Deteriorated**

Infiltration: ☐ None ☒ **Joint** ☐ Cracks ☐ Mortar ☐ Roots ☐ Wall

2.5" Frame Offset; Frame Leaks,  
CHimney Joint Infiltrationand  
Deterioration

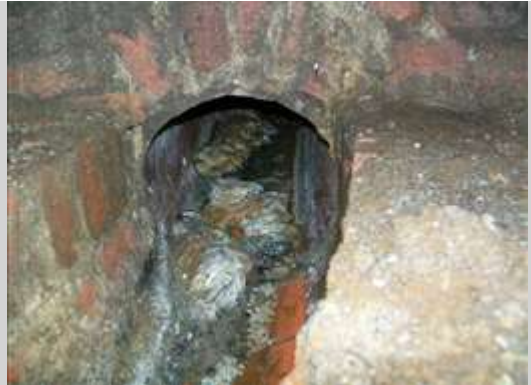
12 O'Clock Outflow

8 in. Circular Gravity Sewer  
Pipe Out @ 12 O'Clock

Pipe Height: **8.4** (in.) Rod and Bar (Angled)  
Pipe Material: **Clay** ☐ Pipe Lined  
Invert Depth: **11.88** (ft.) Flow Characteristics: **Slow**  
Deposits: ☐ None ☐ Mud ☒ **Sludge** ☐ Debris ☐ Grease  
Silt Depth: **2** (in.) Deposits Extent: **Light**  
Infiltration: **None** Pipe Seal Cond: **Sound**

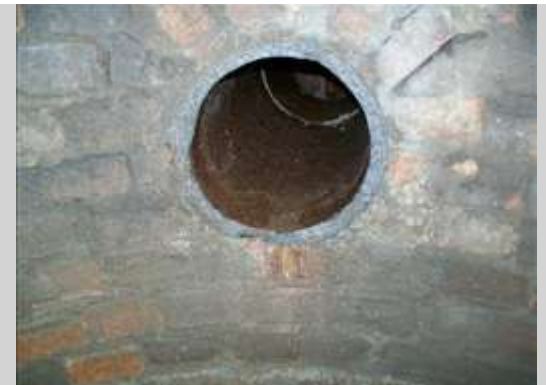
8 O'Clock Inflow

8 in. Circular Gravity Sewer  
Pipe In @ 8 O'Clock

Pipe Height: **8.4** (in.) Rod and Bar (Angled)  
Pipe Material: **Clay** ☐ Pipe Lined  
Invert Depth: **10.00** (ft.) Flow Characteristics: **Slow**  
Deposits: ☒ **None** ☐ Mud ☐ Sludge ☐ Debris ☐ Grease  
Silt Depth: **0** (in.) Deposits Extent:  
Infiltration: **None** Pipe Seal Cond: **Sound**

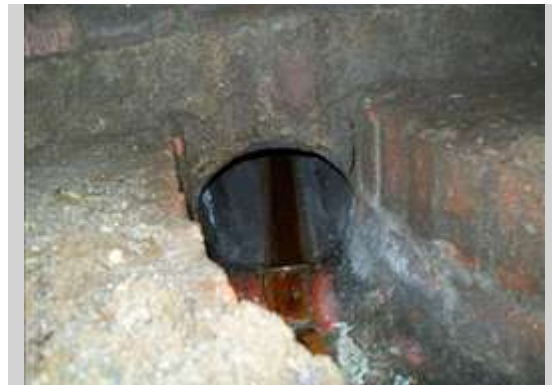
Drop In @ 8 O'Clock

Drop: **Outside** Rod and Bar  
Angled: **Yes** Reading: **10.75** (ft.)  
Inv Depth: **11.75** (ft.)  
Drop Condition: **Open**
